Experiences with superduplex stainless steel in seawater

R. Francis and G. Byrne, Weir Materials & Foundries, U.K.

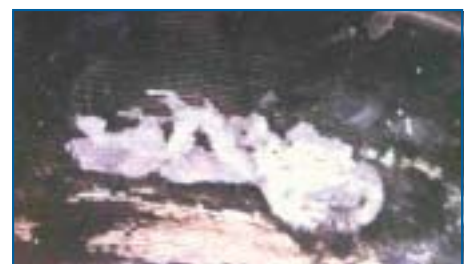
When high alloy stainless steels were first used in the North Sea there were a number of corrosion problems due to galvanic corrosion. Many of these manifest themselves as crevice corrosion. One of these involved graphite loaded gaskets. Kain² carried out tests on a range of gaskets, including graphite loaded ones, and found crevice corrosion similar to that seen with PTFE gaskets. However, Rogne and Drugli³ showed that the severity of crevice corrosion with a gasket depends on its ability to absorb water. Synthetic fibre gaskets absorb a lot of water and dilute the strong crevice solution, while PTFE gaskets absorb no water and are more likely to cause crevice corrosion. Rogne et al³ also pointed out that graphite only caused a galvanic problem when the covering of the graphite is damaged, exposing the graphite to water. Unfortunately this is an occurrence that is frequent on offshore platforms. Figure 3 shows crevice corrosion of a Zeron 100 flange in contact with a graphite gasket in service. Turnbull⁴ showed why

graphite coupled to high alloy stainless steel would be detrimental in chlorinated seawater but not in natural seawater. Because of this graphite gaskets are now banned by many oil companies⁵ and synthetic fibre gaskets are preferred for low pressure (10 bar) seawater system⁵.

Figure 3. Corrosion of a Zeron 100 flange caused by the use of a graphite-filled gasket.
