# Area of Use for Z100 (UNS S32760) Superduplex Stainless Steel Wireline.

R Francis and G Warburton Weir Materials & Foundries

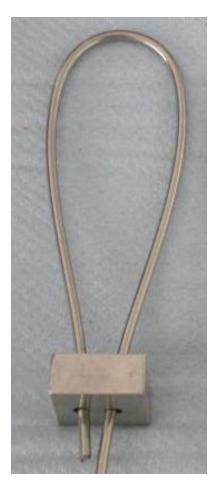
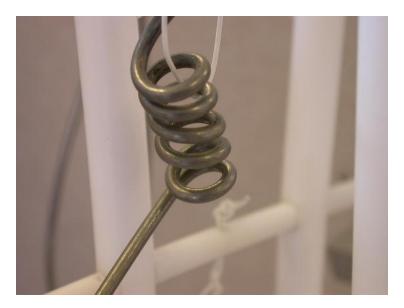
FIGURE 2 Appearance of corrosion test samples, A) U-bend, B) wire wrap

All of the corrosion tests described below were conducted on cold worked wire tested as both U-bends and wrapped wire, as shown in Figure 2. The wire was 0.092" diameter and was bent around a 1" od bar for the u-bend samples. All testing was in accordance with EFC  $17^3$ .
