Presented at Duplex 2010, Beaune France, October 2010

QA/QC tools to ensure the quality of duplex fittings and other components

R. Francis¹, G. Warburton¹, G. Byrne¹ and J. Wilson²

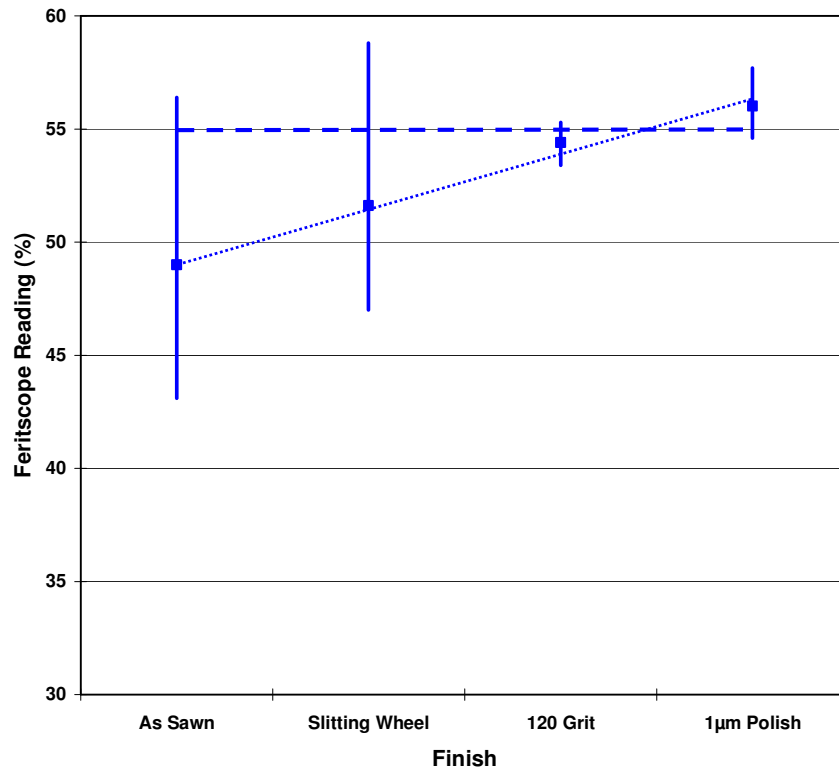
The 2" od bar was examined on the end face in four conditions. These were:

- a) as sawn (hack saw)
- b) as cut (slitting wheel)
- c) abraded (120 grit silicon carbide)
- d) polished (1 μ m diamond)

Ten readings were taken on the end face in each condition. The results are shown in Figure 1.

Figure 1 Effect of surface finish on Feritscope readings.

The results in Figure 1 show that the scatter in Feritscope readings is greatest with the roughest surfaces. Because of this, it could be argued that a mean value of 55% could be drawn through all the readings. However, taking the mean values for each finish, there is a trend of increasing Feritscope reading as the surface becomes smoother. This increase is about 7% from the roughest to the smoothest and it is not a particularly big change as Feritscope readings go. The readings also get higher than the actual ferrite content as the surface becomes smoother.

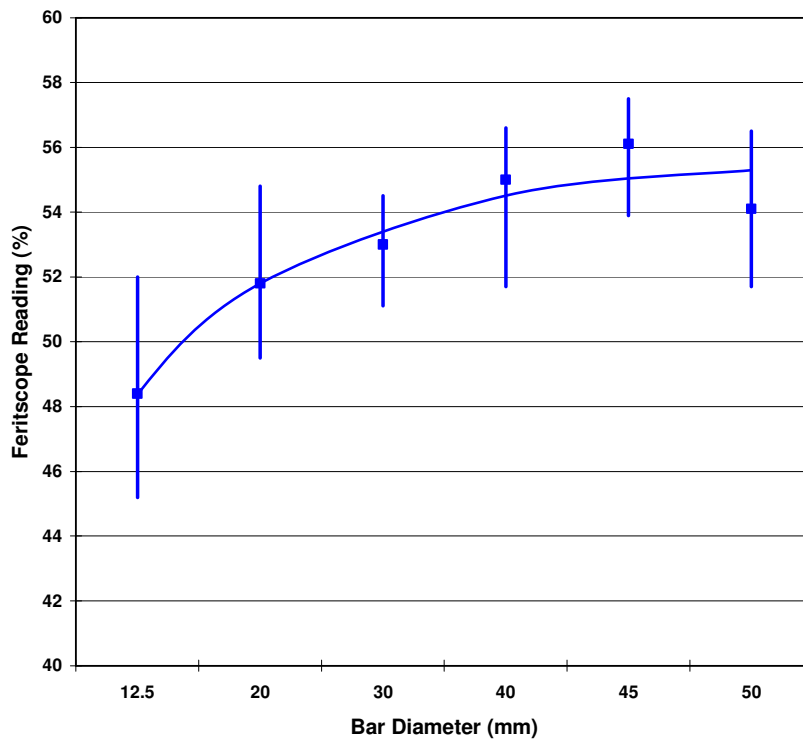
Readings were taken from a single sample of the 2" bar and several millimeters at a time were machined from the diameter and the readings were repeated after each operation. This was done from a bar diameter of 50mm down to 12.5mm. As before, ten readings were taken on each curved surface. The machining operation meant that the surface finish and any surface cold work from machining were similar for each bar diameter. The results are shown in Figure 2 and as a fraction of the polished flat face reading in Figure 3.

Figure 2 Feritscope readings as a function of bar diameter.

Figure 2 shows the effect of bar diameter on the Feritscope readings. The effect is most noticeable at small bar diameters and at 12.5mm, the reading is ~7% lower than at 50mm diameter. The change of reading with curvature in Figure 2 is of the same magnitude as reported by Fisher in the Feritscope operating manual. Again the readings are higher than the actual ferrite content. Figure 3 shows the data as the ratio of curved to flat surface reading and this shows the same trend as in Figure 2. The ratio would be expected to approach unity as the bar diameter increased, but this does not seem to happen as the curve appears to be leveling off at 50mm diameter. However, this is probably due to surface cold work, as described below.

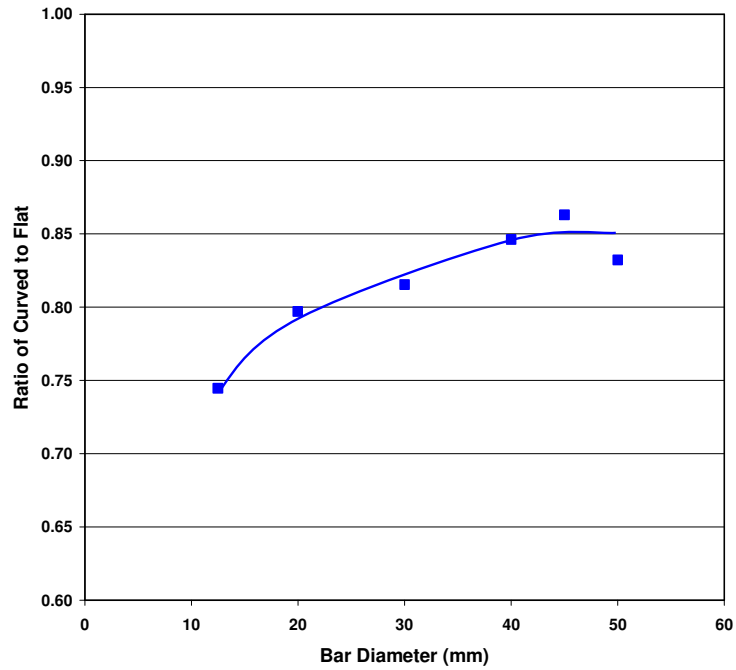
Figure 3 Effect of bar diameter on Feritscope reading ratio.

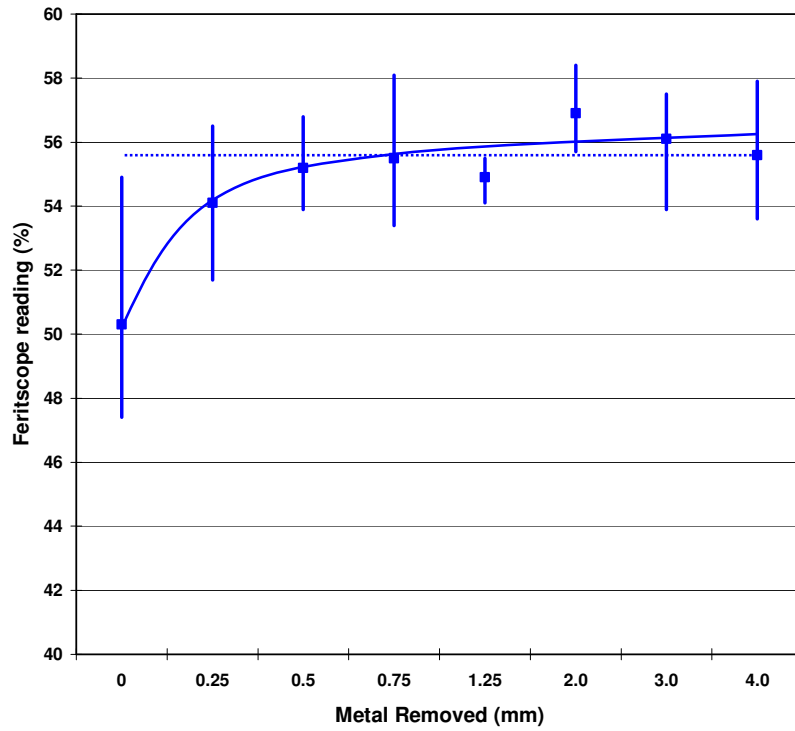
When bar is produced it is straightened after heat treatment, which means that the surface has a small amount of cold work in it. To determine what effect surface cold work from the manufacturing process would have on the Feritscope readings, small amounts of metal were machined from the diameter of a piece of 2" od solution annealed bar. Initially these increments were 0.25mm, but the increment was increased as metal was removed, until the total reached 4mm. Ten Feritscope readings were taken after each machining operation. The results are shown in Figure 4.

Figure 4 Effect of removing metal from diameter of 2" bar.

The results in Figure 4 show a slight increase in Feritscope reading between the surface and the interior. The results also show that the surface effect only extends to a depth of ~0.3mm from the surface. Other surface treatment processes, such as shot peening, show a similar range of penetration from the surface. The change in reading is not large, being only about 6%. The lower readings at the surface suggest that the method of production introduced a moderate level of cold work just in the surface layer.

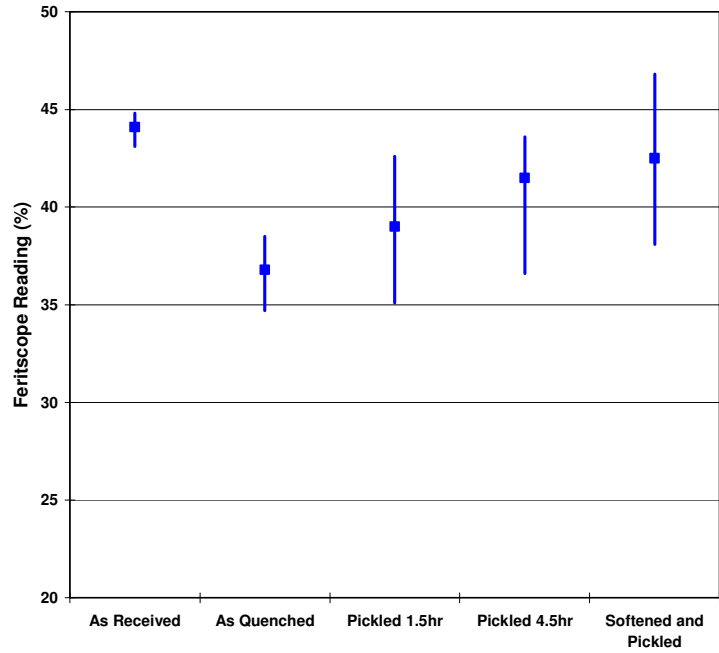
However, samples are normally pickled after a solution anneal at 1050°C to 1120°C, depending on the grade of duplex stainless steel. A piece of 0.5" od bar, 100mm long was heat treated at 1120°C for 1 hour followed by a water quench. Feritscope readings were then taken on the curved surface of the as-quenched bar, while still covered in oxide. The bar was then pickled at 50°C for 1½ hours. Some oxide still remained and the Feritscope readings were taken on the curved surface. The bar was then pickled for a further 3 hours at 50°C (4½ hours total) which removed more oxide,

Figure 5 Feritscope readings after various treatments of 0.5" bar.

but some still remained. Feritscope readings were again taken on the curved surface. Finally, the bar was cleaned in softening solution and then pickled, both at 50°C, as described above. The bar was now free of oxide and Feritscope readings were again taken on the curved surface. The results are shown in Figure 5.

The results in Figure 5 show the effect of heat treatment and pickling 0.5" od bar. The lower readings in the as-quenched condition are not surprising as the oxide will separate the probe from the metal surface and reduce the reading. The results also show that the readings increase towards that of

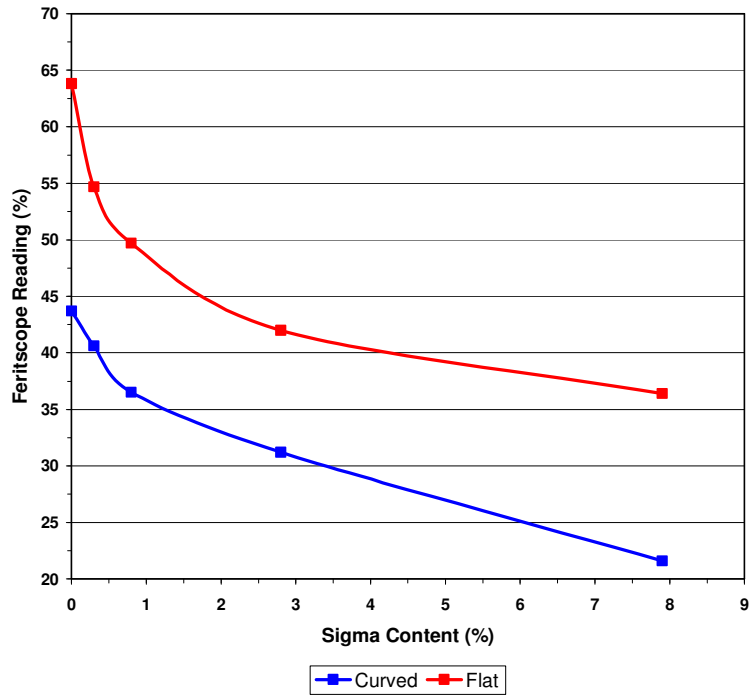
Figure 6 Variation of Feritscope reading with sigma content.

To determine how Feritscope readings change in the presence of third phases, compared with the other factors described above, some 100mm long samples of 0.5" od bar were heat treated to induce sigma/chi phase. A thermocouple was wired onto the side of the bar and it was placed in a furnace set at 850°C. When the temperature of the bar reached 800°C the clock was started. Samples were exposed for 1, 3, 5 and 10 minutes. The sigma/chi phase was determined by LECO image analyzer from a microsection from each bar. The content was taken as the mean of ten fields. Ten Feritscope readings were taken on the curved surface of each bar. The results are shown in Figure 6.

Figure 6 shows the change of Feritscope reading with sigma content, as determined by metallography. There is a clear decrease in the reading with increasing sigma content and the decrease is ~7% for 0.8% sigma and ~22% for 7.9% sigma, on a curved surface and even greater on a flat surface (14% and 27% respectively).
