# **NACE CORROSION 2006**

## **Paper 06216**

### **THE PERFORMANCE OF Z100 (UNS S32760) SUPERDUPLEX STAINLESS STEEL IN SULPHURIC ACID.**

R Francis and G Byrne  
Weir Materials & Foundries  
Park Works  
Newton Heath  
Manchester  
M40 2BA  
U.K.

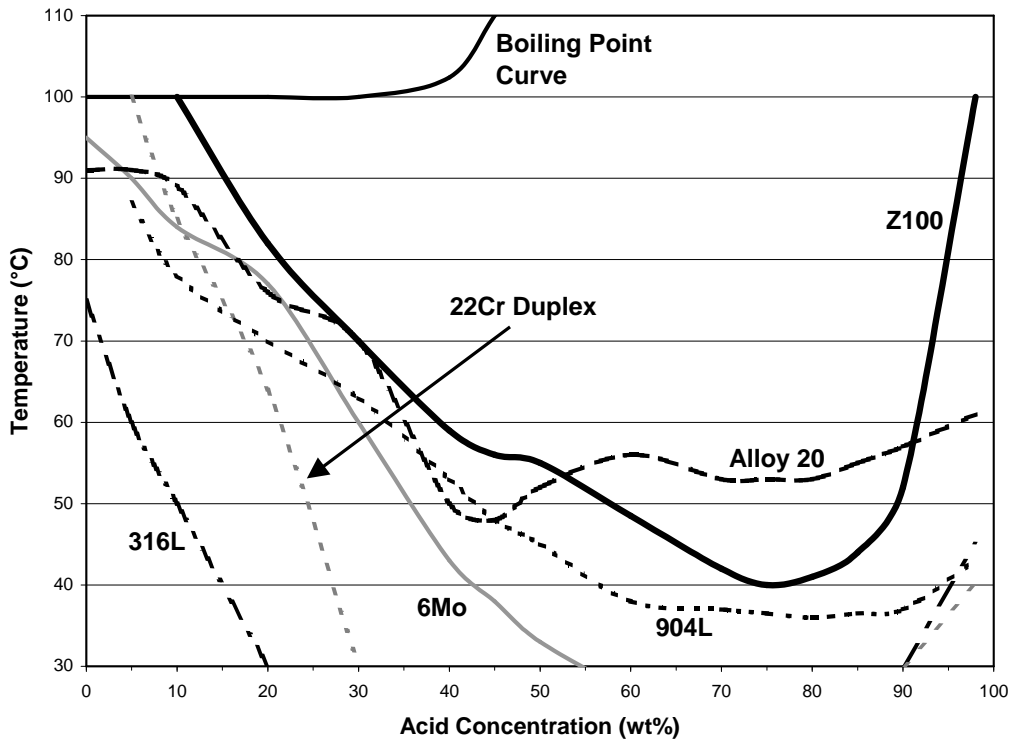
A common engineering design criterion is that the corrosion rate should not exceed ~0.1mm/y. Figure 1 shows the iso-corrosion curve (0.1mm/y) for a number of alloys in pure sulphuric acid. The curves show that Z100 offers superior performance in both dilute and concentrated acids. Only in the range 50% to 80wt% acid does alloy 20 offer any improvement.

**FIGURE 1 Iso-corrosion (0.1mm/y) curves for some stainless steels in sulphuric acid**

It was estimated that in the steam return lines there would be 1 to 3g/l of acid carry over into the heaters. Z100 has good resistance to sulphuric acid, as shown by Figures 1 & 2. As the acid would be vapour during normal operation, no serious corrosion was expected. Condensation during start up and shut down would give a little corrosion, but this was not expected to be serious as it would only be transient. It was concluded that Z100 would be suitable for the steam return lines.

The iso-corrosion curve in Figure 1 shows the good resistance of Z100 to strong sulphuric acid (>95wt%). However, the shape of the curve shows a strong dependence of corrosion rate on acid strength. Rodda<sup>7</sup> has described the problems with carrying out laboratory tests in strong sulphuric acid. It is easy to produce data showing lower corrosion rates than would actually occur due to the presence of small quantities of corrosion products. Hence, all the tests on Z100 were conducted by Kvaerner-Chemetics, who design and build sulphuric acid plants.

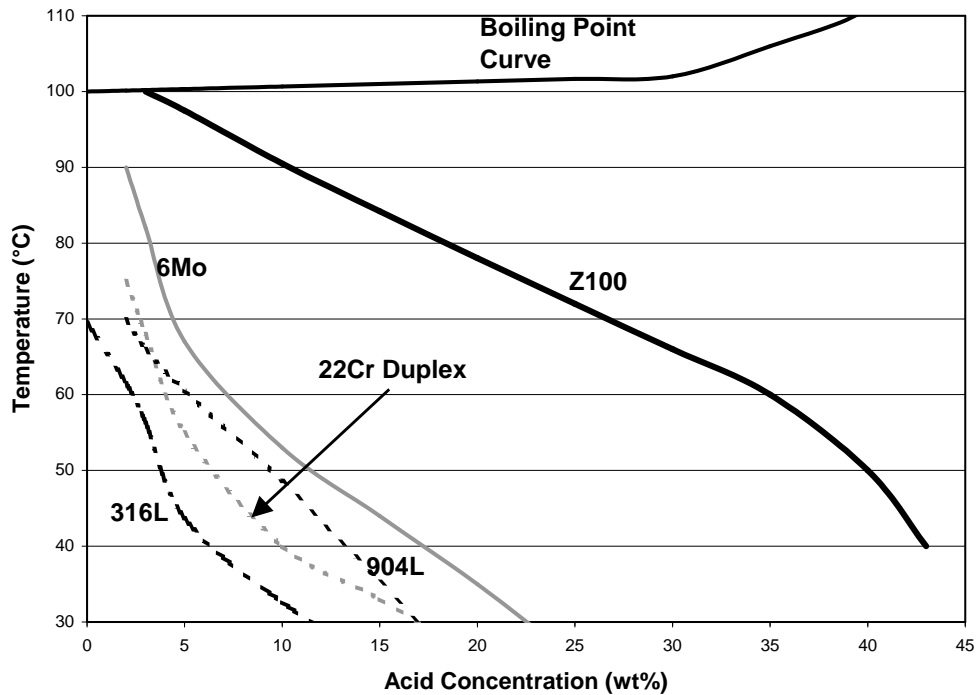
In many service environments chlorides are also present. These usually reduce the performance of most alloys in sulphuric acid and they can change the nature of the corrosion from general attack to a combination of general corrosion and pitting. Figure 2 shows the iso-corrosion curves (0.1mm/y) in sulphuric acid with 2,000mg/l chloride. Alloy Z100 shows superior performance across a wide range of acid concentrations. Alloy 20 was not included in this graph as it has been observed to pit in acid/chloride solutions<sup>2</sup>. The performance of Z100, along with that of other alloys, improves in the presence of oxidisers in the acid (eg. ferric ions, Fe<sup>3+</sup>), up to the onset of transpassive corrosion, and decreases as the chloride concentration increases.

**FIGURE 2 Iso-corrosion (0.1mm/y) curves for some stainless steels in sulphuric acid plus 2,000mg/l chloride**

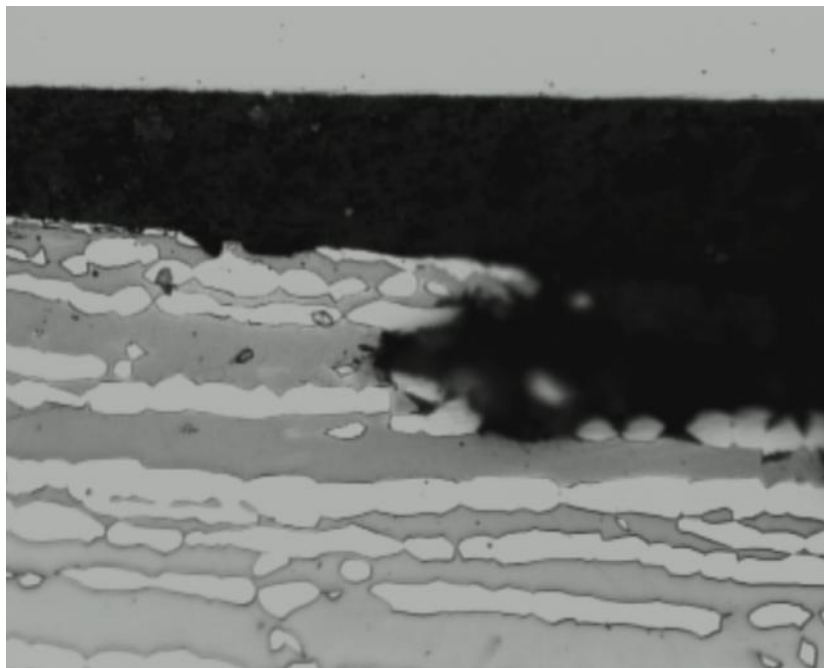
← 50µm →

FIGURE 7 microsection through pitting corrosion on superduplex stainless steel from a HPAL heater. (Etchant: Electrolytic 10% oxalic acid & electrolytic 40% KOH).

Three Australian HPAL laterite projects were built and ramp up began in 1999. Problems occurred in a number of areas, not just due to corrosion<sup>3</sup>. Corrosion of superduplex was observed in the steam transfer lines, the heater vessels and the slurry injection pumps. This was not confined to Z100, but was also seen with other superduplex grades, such as UNS S32750. This mostly took the form of pitting, but stress corrosion cracking from the base of the pits was seen in the steam transfer lines and the heater vessels. Details of the attack can be seen in Figures 6 and 7.

The problem in the plants meant that shut downs and start ups were frequent. In the initial corrosion tests it was assumed that the steam would strip the bulk of the oxygen from the incoming slurry. However, with frequent stops and starts it was likely that a significant dissolved oxygen content would be present for much of the time at temperature. A corrosion test was carried out for 30 days at 200°C with a simulated shut down every five days. All the samples showed pitting attack (Figure 8), which was similar to that in Figure 6 and 7<sup>4</sup>.

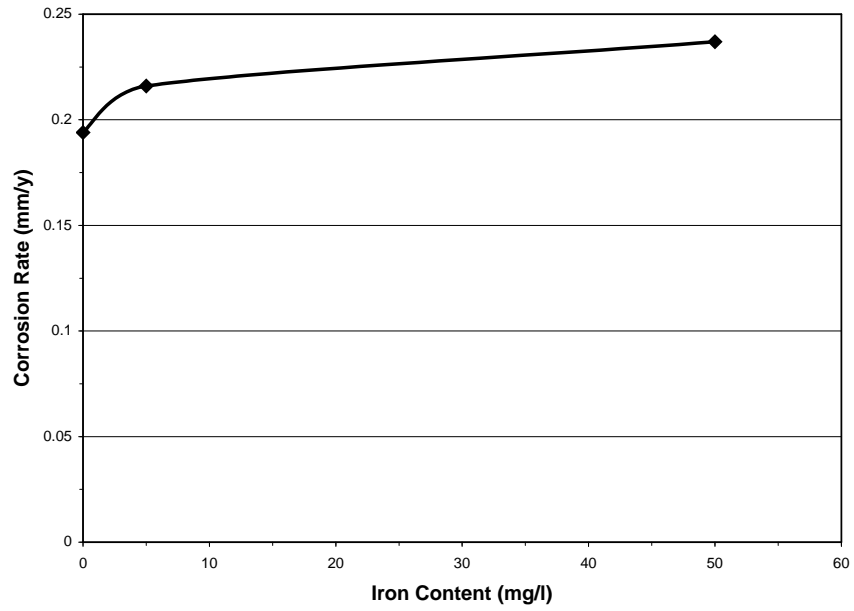
Figure 9 shows the corrosion rate of Z100 in 98% sulphuric acid at 200°C as a function of ferric ion content. The results show the corrosion rate to be moderate and ferric ion concentration has little effect. Tests on Z100 seam welded heat exchanger tubes showed a similar rate of corrosion and no preferential attack of the weld.

**FIGURE 9 Corrosion of Z100 in 98wt% sulphuric acid at 200°C versus ferric iron content**
